A crystal clear solution

Mike Deed, of Geoquip Water Solutions, reports on the treatment of geothermal plant with Boresaver at a retail/industrial complex in Milan, Italy

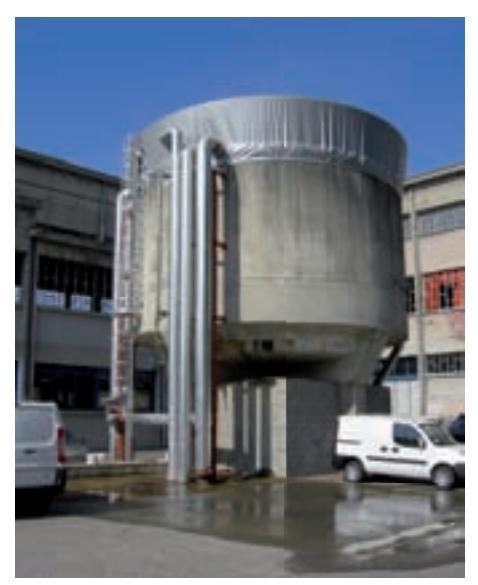
System storage tank

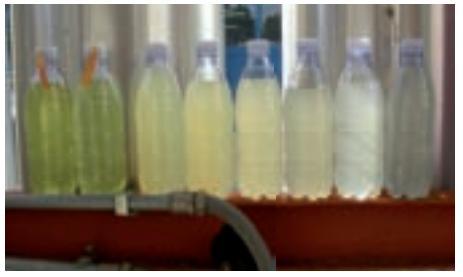
Monitoring during purging as the iron in solution (green) passes to clear water

The secondary systems were cleaned using the Boresaver Ultra C by pre-dissolving the chemical in industrial bulk containers and then pumping this solution using small, circulating pumps around the various systems. Once inside, the main circulating pumps were used to re-circulate the treatment water for a period of 24-48hrs, following which the system was purged with fresh water from the wells and then finally refilled.

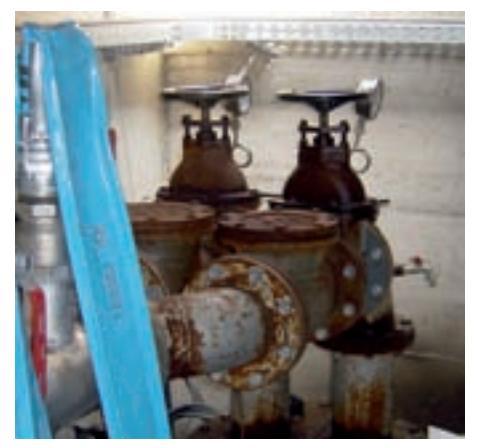
Well extraction point during recycling

The first part of the system to be treated was the extraction well. Then the treated water was used to fill the whole system, including the secondary loop that had compromised every part of the system. The pumps and system remained intact whilst the treatment was carried out. This reduced plant downtime and minimised the cost of rehabilitation. Following treatment of the wells, the pumps were used to manage the movement of further Boresaver Ultra C treatment throughout the rest of the distribution pipework, evaporators and condensers of the heat exchanger. The complete treatment of each well and distribution system was completed within four days.
