CASE STUDY

Public Water Supply, Belfast (N Ireland)

Client: Water Services, NI
Location: Belfast, N Ireland
Product: BoreSaver Ultra C
Project Description: The remediation of a well that had been abandoned 3 years previously due to extensive iron oxide and iron bacteria clogging
Keywords: BoreSaver Ultra C, public water supply, remediation, iron bacteria, iron oxide deposits

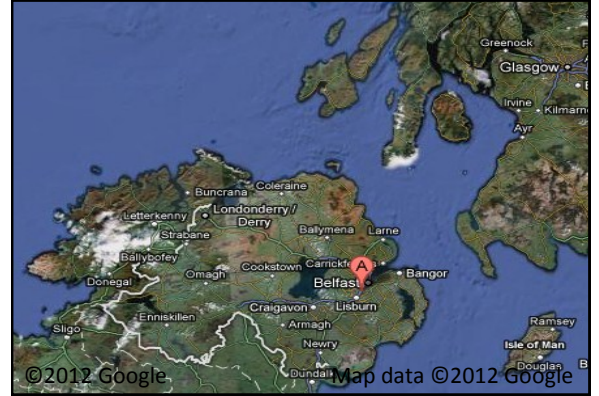
A 98m deep bore, used to supply public water for Belfast, had been abandoned three years previously due to severe iron oxide and iron bacteria contamination. A downhole video camera survey revealed that the well liners were completely clogged, with up to 5cm of film observed over a 40m length of the PVC liner. The well was unable to sustain yields of more than 0.2MI/day, despite an original yield of around 4MI/day in the early 1970's.

BoreSaver Ultra C was added to the well, resulting in removal of the iron bacteria and iron oxide deposits. The residues safely pumped away to waste. Subsequent pumping tests indicated that the original borehole yield of 4MI/day had been restored. Within one week of the remediation being completed, the borehole was brought back into public supply for the first time in 3 years.
