## CASE STUDY

# Hydraulic Barrier, Falconara (Italy)

<b>Client:</b>	Undisclosed
<b>Location:</b>	Falconara/ Italy
<b>Product:</b>	BoreSaver IKL, BoreSaver Ultra C Pro
<b>Project Description:</b>	The hydraulic barrier well for an industrial site in Falconara was contaminated with algae, calcium carbonate and iron bacteria
<b>Keywords:</b>	BoreSaver IKL, BoreSaver Ultra C Pro, hydraulic barrier, calcium carbonate, iron related bacteria

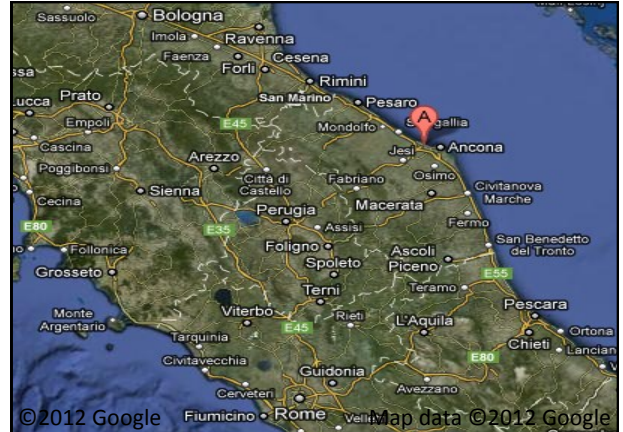
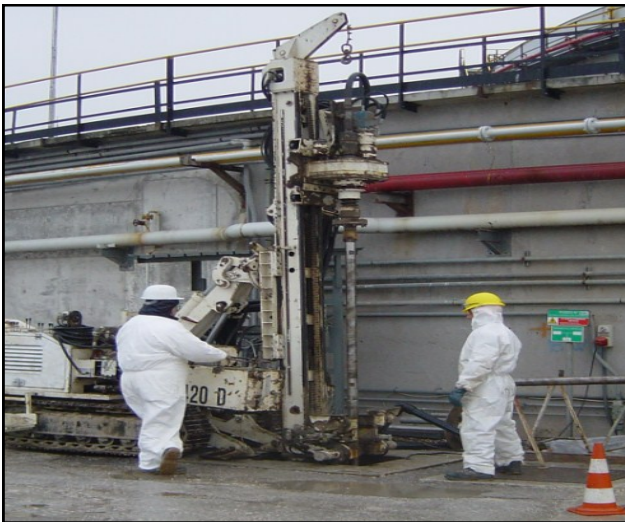
The hydraulic barrier for an industrial site in Falconara was significantly underperforming, achieving only 12m<sup>3</sup>/hr with a drawdown of 8m. A downhole video inspection revealed algae, calcium carbonate and iron bacteria contamination which had clogged up the screen slots and the pump as well as reducing the quality and output of the water. The well is 400mm in diameter and 10.5m deep.

The pump was removed from the well which was then treated with IKL Pro, Ultra C Pro and caustic soda in pearls using a piston cleaning technique. The pump was cleaned using a large barrel filled with water and Ultra C.

Following two treatments, 24 hours apart, the majority of the screen slots were completely open and the algae, calcium carbonate and iron bacteria almost completely eliminated. The submersible pump was re-installed and tested, and now achieved 28m<sup>3</sup>/hr with a drawdown of only 4.7m, an increase of 233%. As this level of pressure was not required, the flow was reduced to 21m<sup>3</sup>/hr with a drawdown of 4.40m.
