CASE STUDY

Keeping a nursery garden blooming (UK)

Client:	Nursery garden
Location:	Suffolk, UK
Products:	BoreSaver Ultra C Pro & BoreSaver Multikleen
Project Description:	Clean and treatment programme for a nursery garden borehole
Keywords:	BoreSaver, borehole, iron related bacteria, IRB, airlift, brush and clean, Treewaters, Geoquip

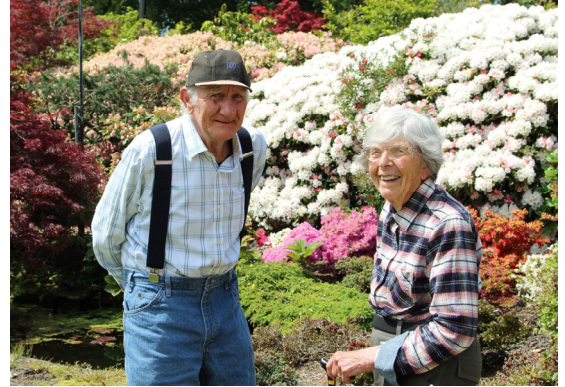
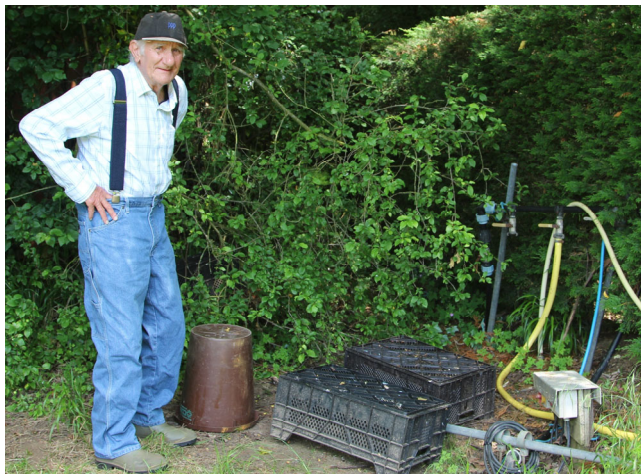
With a 6.5 acre nursery garden, renowned plantsman and horticulturalist Brian Humphrey relies on borehole water for his irrigation system. Over time, the water's high iron content led to decreasing yield, as both the pump and pipes became blocked by residue.

Now, thanks to a combination of the treatment programme and a full-scale clean (including an airlift and brush and clean) carried out every few years by Treewaters Control Systems; the borehole maintains a yield of 25-30 litres a minute from April-September, making sure the nursery garden plants stay in tip-top condition.

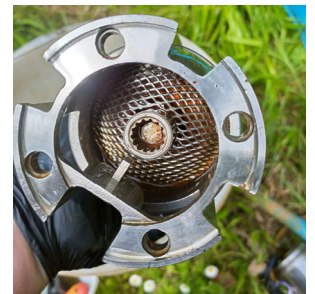
BoreSaver is designed to tackle problems such as IRB and is completely biodegradable. Before pictures (below) show the extent of the iron-related bacteria residue build-up on the top of the pump (left) and on the water intake at the bottom. The after photos were taken once the clean and treatment programme had been completed. Regular BoreSaver applications ensure the IRB is kept at bay.

Having bought new pumps, which didn't solve the problem, Brian turned to Geoquip Water Solutions who recommended tackling the iron-related bacteria (IRB) using regular applications of its BoreSaver water treatment solution.
