CASE STUDY

Why borehole bacteria has had its chips (England)

Client:	Potato and vegetable farmer
Location:	East Anglia
Products:	BoreSaver Ultra C Pro
Project Description:	Borehole performance impacted by bacteria and affecting crop irrigation
Keywords:	Boreholes, bacteria, camera survey, BoreSaver Ultra C Pro, irrigation, potatoes, agriculture, crop irrigation

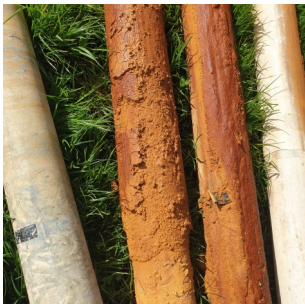
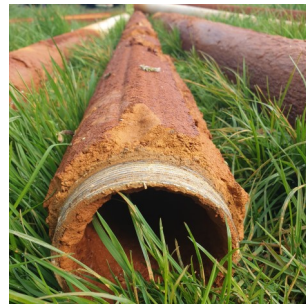
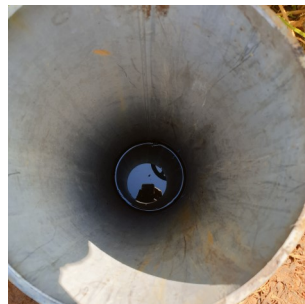
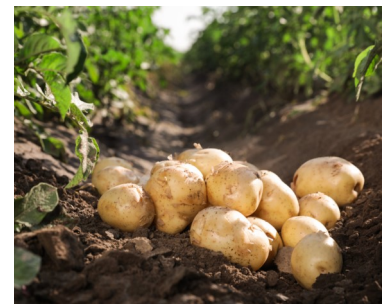
The survey revealed a build-up of residue and biofilm, caused by iron-related bacteria (IRB), was blocking the pipes and borehole casings. A brushing and cleaning programme was carried out, followed by a treatment of BoreSaver Ultra C Pro, supplied by Geoquip Water Solutions. Specially designed to eliminate iron bacteria in boreholes, it includes a biodegradable marker, guaranteeing no chemical residue is left in the water supply, ensuring no detrimental impact on any crops.

The severity of the problem meant two doses were required, together with further cleaning. Maintenance doses have since helped keep the bacteria at bay and yield has now returned to around 1.5m³.
