# Renaissance Golf Club, Scotland (UK)

<b>Client:</b>	The Renaissance Club
<b>Location:</b>	East Lothian, Scotland
<b>Products:</b>	BoreSaver Ultra C PRO
<b>Project Description:</b>	Treating a borehole blockage at a golf club caused by iron-related bacteria
<b>Keywords:</b>	Golf course, boreholes, reduced water flow BoreSaver, iron-related bacteria

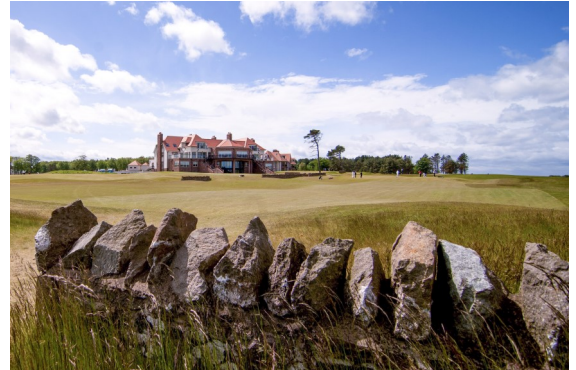
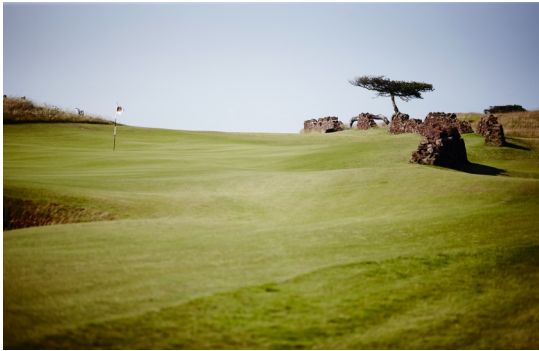
**Paul Seago, Head Superintendent, is in charge of the Club's greenkeeping team. He says: "The borehole is at the heart of our irrigation system but because it is below ground no-one sees it. When those first images came back from the downhole camera, it made sense because we could identify what was going on."**

**"Once the BoreSaver had worked its magic and we saw the post-treatment camera images the difference was like night and day."**

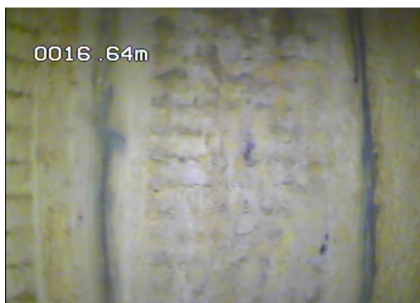
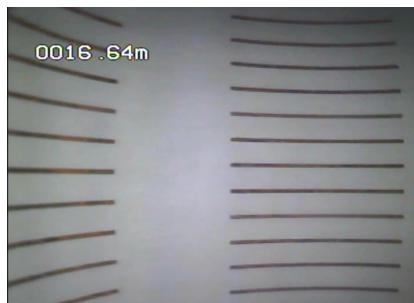
Bryn says: "The borehole casings were badly blocked due to the growth of iron-related bacteria. We used BoreSaver Ultra C PRO, took regular water samples and performed a further camera survey which allowed us to see the borehole was now clear of contamination. Once it was up and running again, it was back to producing 24-25 cubic metres of water an hour, over double what they had before."

A downhole camera survey shows before (left) and after treatment (right) with BoreSaver Ultra C PRO
