How to get to the bottom of borehole problems

Borehole maintenance specialist Geoquip Water Solutions outlines a number of investigation and treatment options for borehole remediation when water yield starts to fall

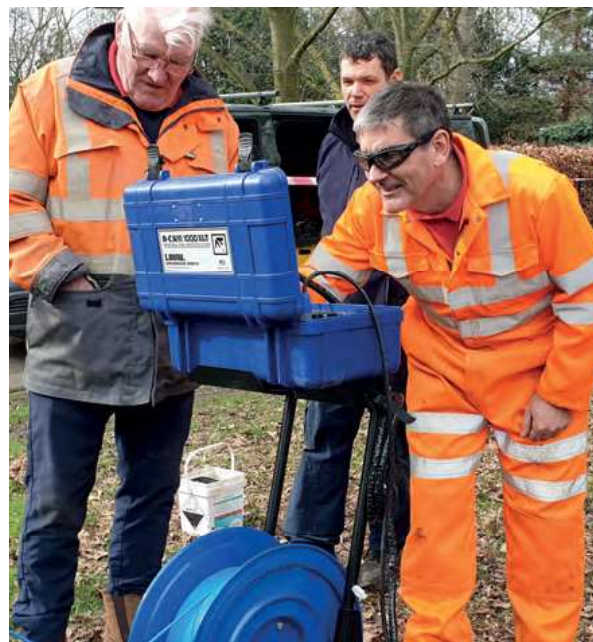
Darren Hughes, from D Hughes Well Drillers checking the images produced by the Laval R-CAM 1000 XLT borehole camera to identify that a borehole was collapsing

Among the recent projects where the camera has been put to good use has been at a large country estate, sporting and events venue on the south coast, where Hughes was called in to investigate a borehole problem and, thanks to the camera, was able to identify that the borehole was collapsing.

"Although the borehole was still cased to 10m, the hole ►

► further down was collapsing in, allowing chalk to fall on the rising main,” he says. “The camera enabled us to see exactly where work was needed and we were able to re-line the casing to solve the problem.”

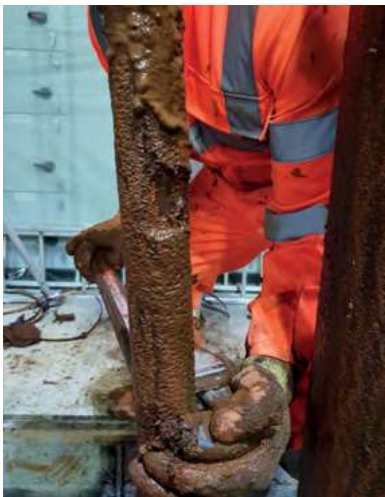
An example of typical iron bacteria residues on a pipe prior to treatment
