Why wrong type of iron almost

left golf course under par

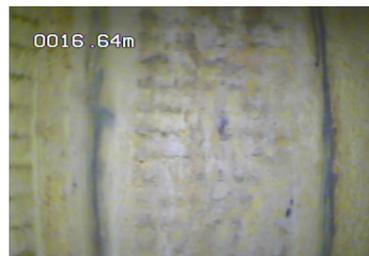
Top: Badly blocked borehole casings which reduced the flow of water. Above: The post-clean result after treatment with BoreSaver

"We could see the borehole casings were badly blocked due to the growth of iron-related bacteria. This prevented the free entry of the groundwater resulting in a reduced flow of water.

"We treated it with a solution of BoreSaver Ultra C PRO, which is excellent at tackling contamination

problems. We brushed and cleaned the well on a Friday, left the solution in the borehole and returned on the Monday morning to do another brush to remove any further residues which had softened over the weekend.

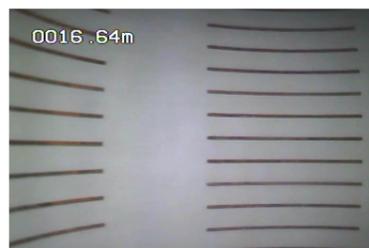
"We took water samples at regular intervals to test the pH and performed a further camera survey which allowed us to see that the borehole was now clear of contamination.

"Once it was up and running again, the borehole was back to producing 24-25 cubic metres of water an hour, which was over double what they were seeing before the clean."
