Beating bacteria for the Italian 'jobs'

In Italy, Milan-based Millars Products specialises in borehole rehabilitation and remediation, which includes the use of Geoquip's BoreSaver range of water treatment solutions

Case study – a well deep clean doubles water flow

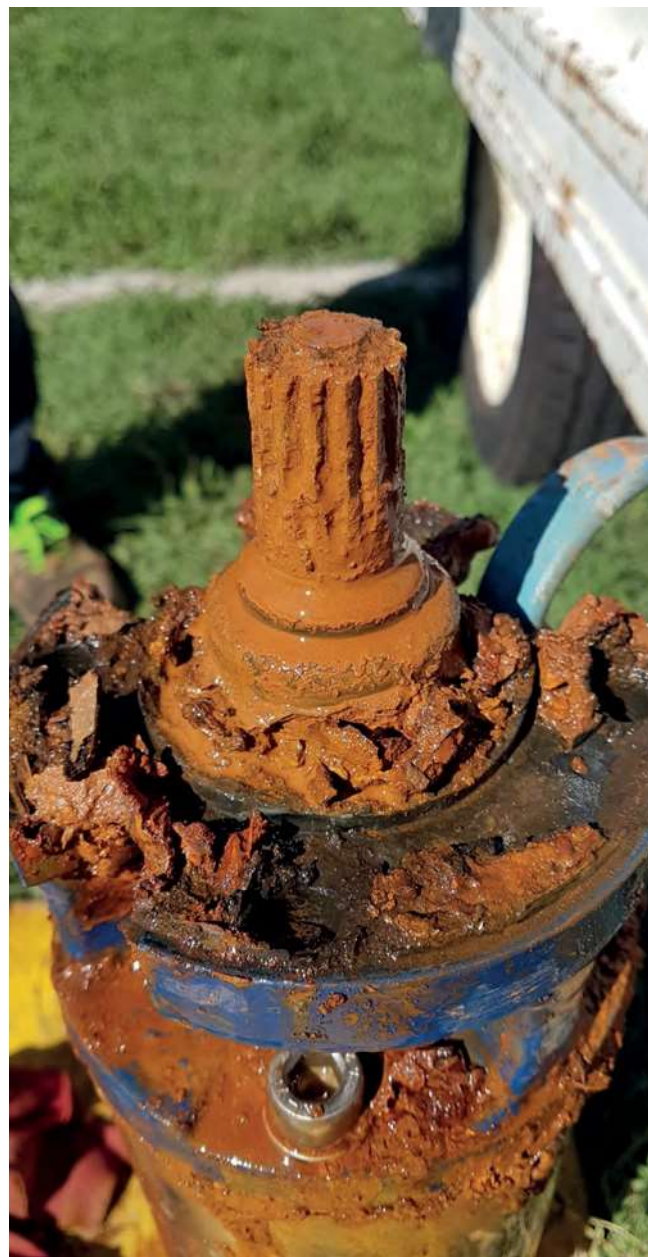
If allowed to go unchecked iron bacteria will grow inside a well very easily and, once it gets established, it can cause massive problems with the equipment and maintenance of the well

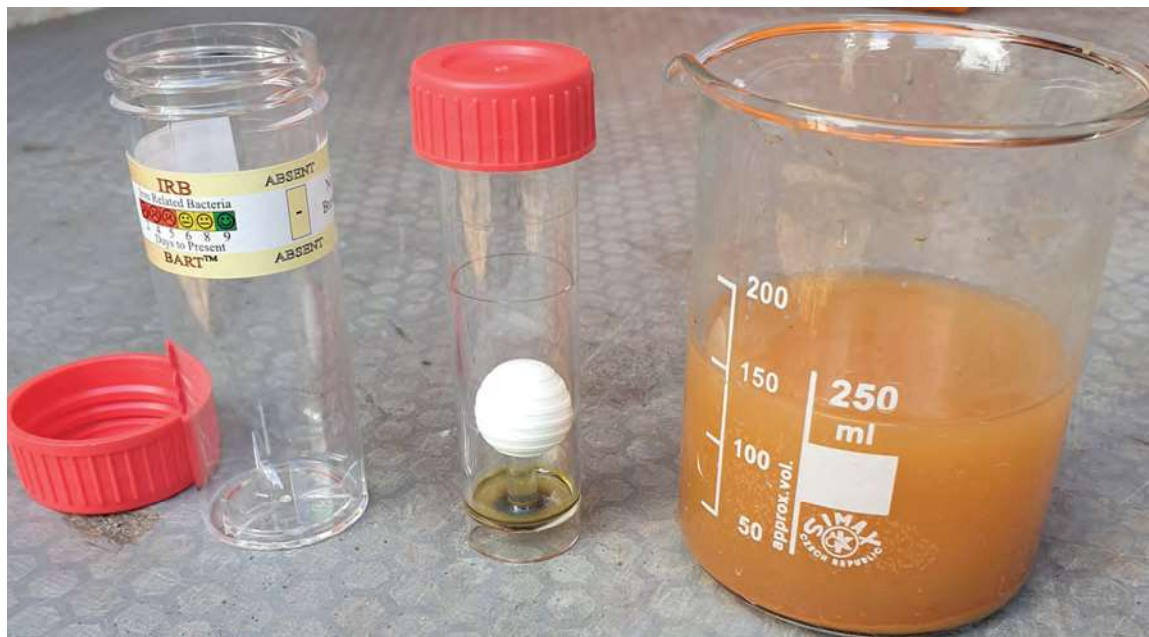
The test vial (centre) once it has been removed from the outer dispenser of the biological activity reaction test (BART) kit

Boyd has a two-pronged plan of attack. The first is to use a biological activity reaction test (BART) kit, which is both simple and cost-effective to use. It involves taking a water sample (container provided) to allow the user to see both if bacteria is present and what type it is – for example, iron-related bacteria, sulphate-reducing bacteria or slime-forming bacteria.

- ▶ within the sample vial. Typically, these will present as:
 - If iron-related bacteria is found, foam will be produced and/or a brown ring develops inside the testing tube
 - If sulphate-reducing bacteria is found, foam will again be produced and a black ring may develop around the interior vial of the testing tube.
 - If slime-forming bacteria is found, a cloudy or gel-like growth will develop

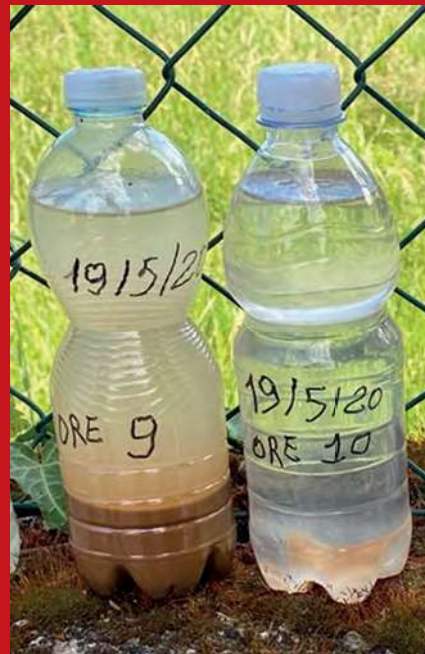
The sample bottle (left) shows how cloudy the water was and demonstrates the mud found in the borehole. The sample (right) was taken one hour later after the mechanical clean but before the chemical treatment

The remedial work, which took place in May this year, saw GN Tecnopompe start with a mechanical clean of the well using a piston and brushing method, with an airlift to remove residual deposits.

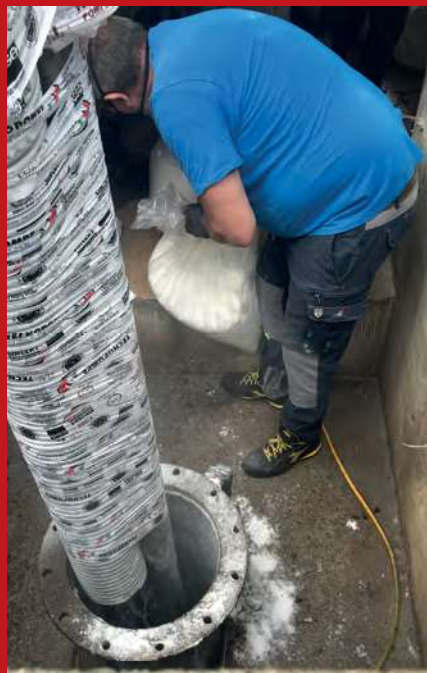
BoreSaver Ultra C is poured into the borehole of a well in Italy that had all but been mothballed due to problems with bacteria dramatically reducing its output

With the initial clean completed, the next stage was to tackle the bacteria with chemicals and the Millars Products team brought in BoreSaver Ultra C Eco, a specialist treatment solution imported exclusively from its UK partner Geoquip Water Solutions.

An application of over 500kg was inserted into the borehole, using the airlift system to create regular purges to help to circulate the chemical. Over a two-day period, water samples were regularly taken for pH testing and, by the end of the second day, the samples were showing a neutral pH with crystal clear water.
