CASE STUDY

Slope Stabilisation, Isle of Wight Coast (UK)

Client:	Isle of Wight Council
Location:	Isle of Wight, UK
Product:	BoreSaver Ultra C & BoreSaver Liquid Enhancer
Project Description:	The Isle of Wight Council, have a problem caused by iron related bacteria in their dewatering siphon wells.
Keywords:	BoreSaver, siphon wells, iron related bacteria, ground stabilisation.

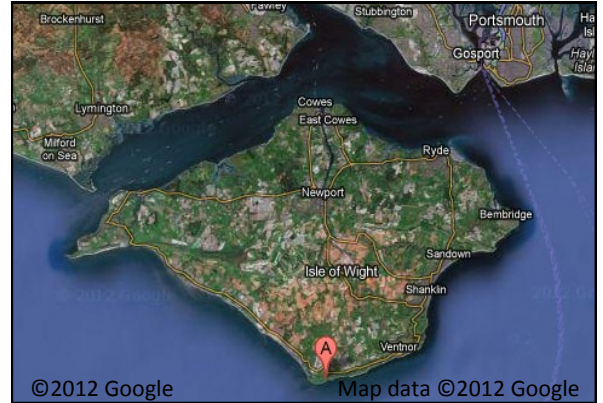
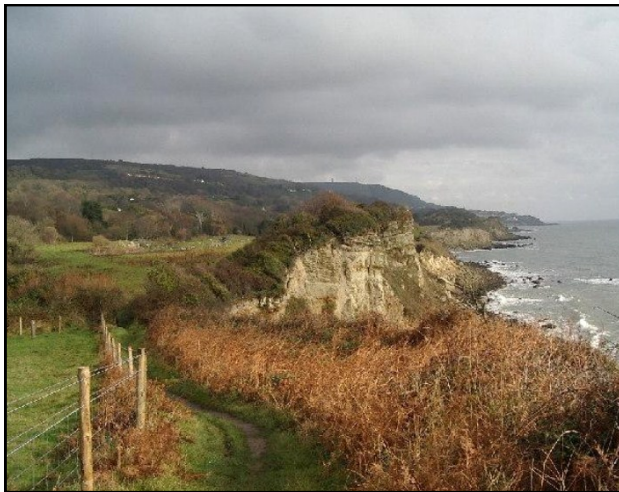
They were having trouble with ground water contamination, possibly from the septic tanks, which was causing iron related bacteria to grow in the ground stabilisation dewatering wells.

A solution that was environmentally friendly and easy to use had to be found to maintain the running of the system and hence stabilise the cliffs. The system comprised over 100 siphon wells interconnected with 10mm pipes hundreds of metres in length via a series of deep chambers where the accumulators were installed.

The Council have used BoreSaver since 2005 and it now forms part of their regular maintenance programme. Twice a year the system is flushed through with BoreSaver which keeps the system from furring up and de-clogs the accumulators where most of the problem occurs. Cleaning the abstraction siphon wells also ensures that the wells continue to yield effectively.
