## CASE STUDY

# Geothermal Plant, Lodi (Italy)

**Client:** Lodi District Council  
**Location:** Lodi, Italy  
**Product:** BoreSaver Ultra C Pro  
**Project Description:** A geothermal plant servicing an air conditioning system contaminated with iron related bacteria .  
**Keywords:** BoreSaver Ultra C Pro, geothermal, iron related bacteria, iron oxide, recharge well

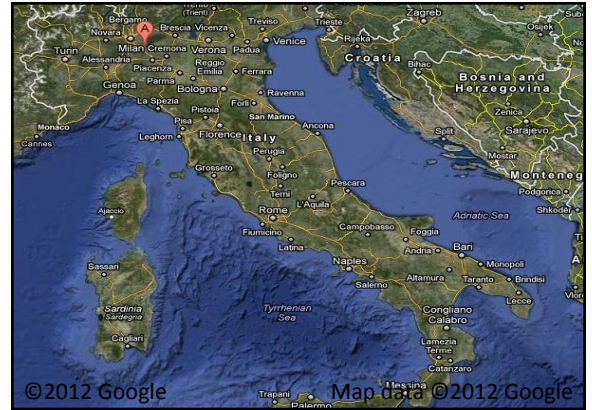
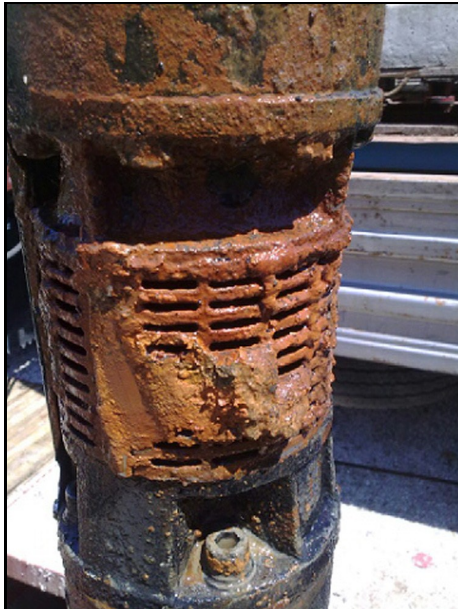
The recharge well for a geothermal system was severely contaminated with iron related bacteria, causing flooding in adjacent areas and forcing the system to be switched off.

A video inspection of the system showed that both wells were completely clogged with iron bacteria and iron oxide residues. The slots in the screens in the recharge well were completely sealed, preventing the discharge of purged water into the ground.

BoreSaver Ultra C Pro was used to treat the system and a post-treatment inspection revealed the screen slots were virtually clear of contamination and the system was returned to full operational use without subsequent borehole clogging. An ongoing maintenance programme has been introduced to maintain the system.
